# In Pavement Crosswalk Lighting System Evaluation – Pilot Project

## Civic Center Drive at Vera Schultz Drive

City Project No. 11045

October 29, 2004

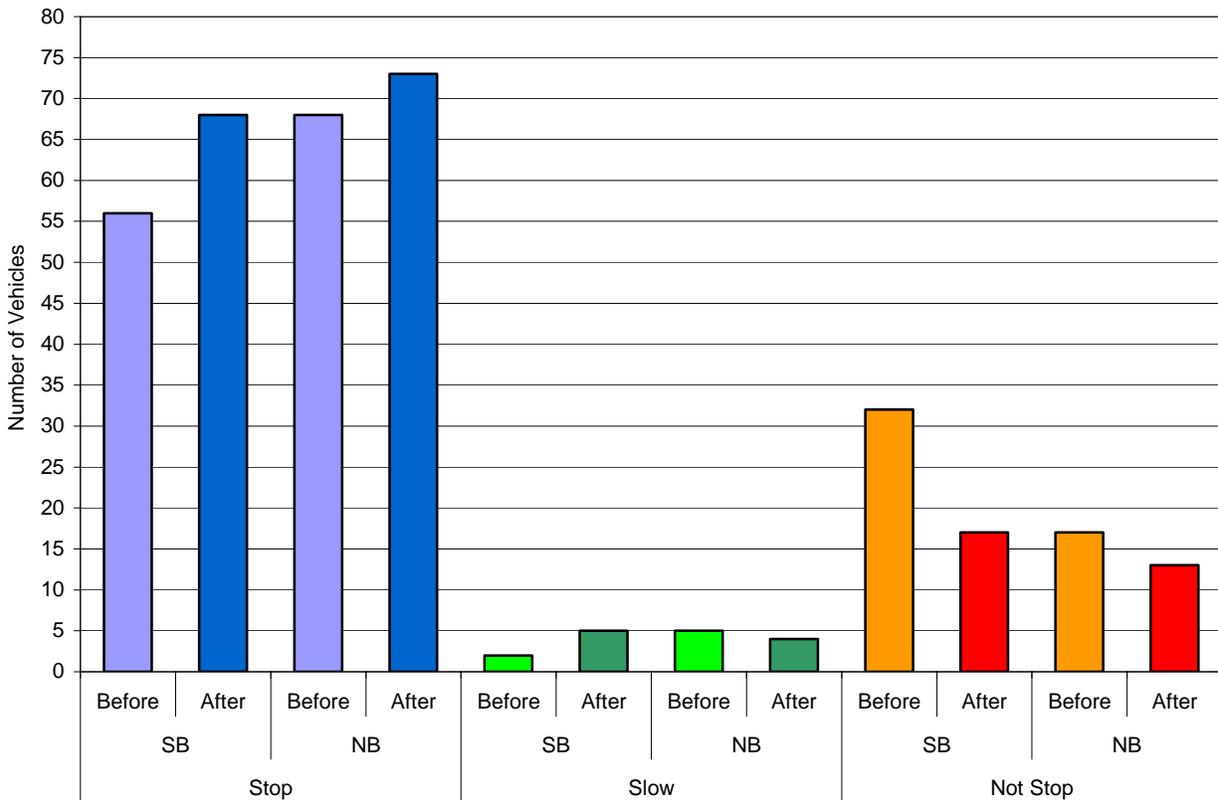
**Exhibit - 1**  
**Driver Reaction Study**

For southbound direction, motorists stopping for pedestrians increased by approximately 7% with the activation of the system. Similarly, vehicle speed of drivers at 50 feet approach to the crosswalk also decreased slightly. The raw data of the before and after study is attached in *Appendix A*.

*Exhibit 1* (shown on next page) summarizes the data results. For northbound direction, motorists stopping for pedestrians increased by approximately 8% with the activation of the system. Similarly, vehicle speed of drivers at 50 feet approach to the crosswalk also decreased slightly.

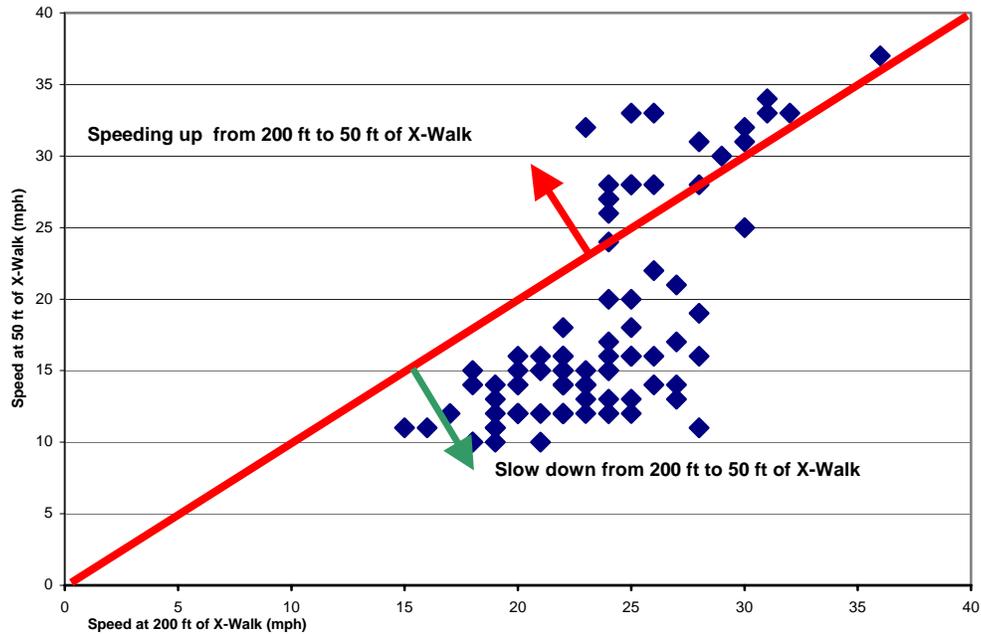
**Exhibit - 2**  
Northbound - Before Study

The following exhibits (*Exhibit 2, 3, 4 and 5*) summarizes the speed analysis in relation to driver reaction before and after the system was installed and activated.

All the ninety samples collected for each approach are depicted on these exhibits, which indicates the overall increase of motorists who stopped for the pedestrians when the system was activated. The raw data of the before and after study is attached in *Appendix A*.
